Contract #: 04-0120F4Cty: SF/ALA Rte: 80 PM: 13.2/13.9File #: 69.28**WELDING INSPECTION REPORT****Resident Engineer:** Pursell, Gary**Address:** 333 Burma Road**City:** Oakland, CA 94607**Report No:** WIR-013534**Date Inspected:** 16-Apr-2010**Project Name:** SAS Superstructure**OSM Arrival Time:** 700**Prime Contractor:** American Bridge/Fluor Enterprises, a JV**OSM Departure Time:** 1900**Contractor:** Zhenhua Port Machinery Company, Ltd (ZPMC), Changxing Island **Location:** Shanghai, China**CWI Name:** Zhao Chen Sun**CWI Present:** Yes No**Inspected CWI report:** Yes No N/A**Rod Oven in Use:** Yes No N/A**Electrode to specification:** Yes No N/A**Weld Procedures Followed:** Yes No N/A**Qualified Welders:** Yes No N/A**Verified Joint Fit-up:** Yes No N/A**Approved Drawings:** Yes No N/A**Approved WPS:** Yes No N/A**Delayed / Cancelled:** Yes No N/A**Bridge No:** 34-0006**Component:** Tower Components**Summary of Items Observed:**

**Tower Trial Assembly**

## WELDING INSPECTION REPORT

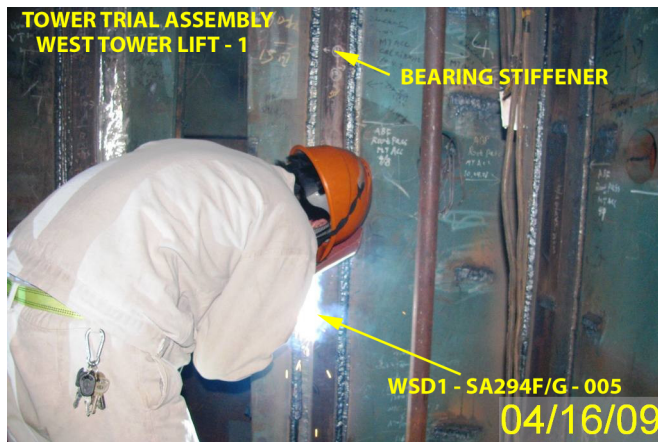
Weld joint # 005 located on West Tower Lift-1 Bearing stiffener WSD1 – SA294F/G. Welder is identified as 049541. ZPMC Quality Control (QC) Inspector is identified as Wang Chuangxin. The welding variables recorded by QC appeared to comply with the WPS – B – T – 2333 – Tc – P4 – F.  
(See attached photo)
